## **Preliminary evaluation of design and construction details to maximize health and well-being in a new built public school in Wroclaw**

**Abstract** The paper presents preliminary evaluation of a design approach and solutions applied in the first sustainable school complex in Wroclaw, Poland. The scope of this paper is focused on health and wellbeing of the occupants. The building completed in the year 2009 is planned for an in-depth POE to start this year – the first such broad evaluation project to be carried out in Poland. Measurements taken already and the feedback from the occupants received so far indicate whether certain design intentions have been met. Selected usability problems that have already occurred are discussed as well as the way the occupants cope with them. Selected details that proved to be successful are also presented. An overview of the process of the building delivery, handover and maintenance is also presented as in the authors opinion it has a major impact on the building's overall performance. The paper concludes that most usability problems are lessons to be learned indicating improvements that can be made in a building's life early stages.

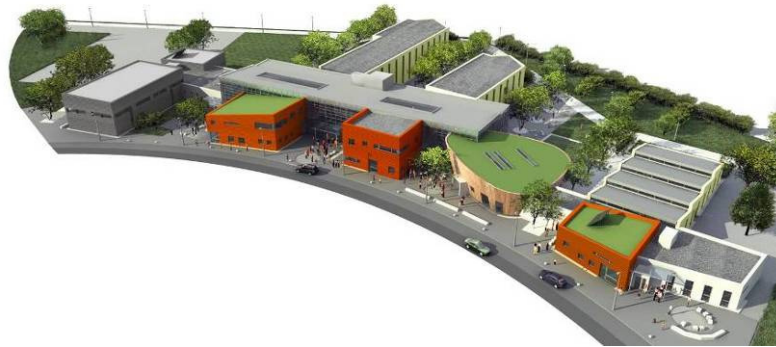
**Fig. 1.1** Visualization of the school complex. © Grupa Synergia

The 6000-square-meters building accommodates 450 pupils and 100 preschool children. There are 80 employees in the building including: teachers, administration and technical staff. The schools population is divided between two classroom wings with shared entrance lobby, library, sport and dining facilities (see Fig. 1.1). The third wing with a separate entrance is dedicated to the preschool. The dining area serves as a connection point between the school and the preschool. The school is located on a greenfield site at Suwalska Street in a currently developing suburban housing district of Wroclaw.

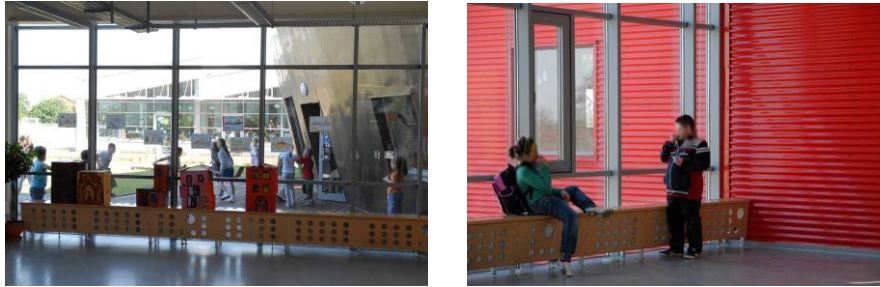
*design:* distinct division between public and restricted access zones and enabling insight into most spaces, extensive glazing, keeping visual links between inside and outside (see Fig. 1.2). Clear functional disposition with distinct color patterns for different sections of the building to facilitate orientation (see Fig. 1.3).

**Fig. 1.2** The main school hall – keeping visual links between inside and outside

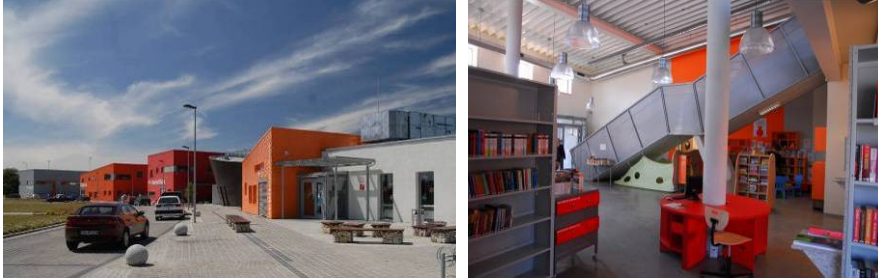
**Fig. 1.4** Distinct volumes with separate entrances for different functions shared with local community a) View towards entrance area, b) School and community shared library

*design:* Separate entrance to sport facilities, library and a multi purpose room. The main lobby may also function as a space for public events after the school is closed (see Fig. 1.4).

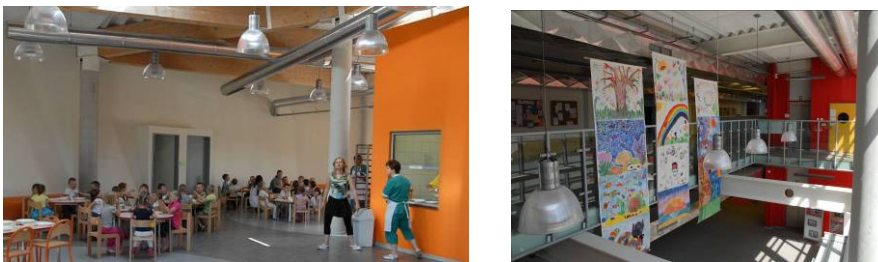
*design:* wherever possible the construction, electrical and ventilation systems are left visible to show how the building functions, porthole windows in most internal doors to allow the children an insight into most spaces including ancillary technical rooms, staff rooms and classrooms (see Fig. 1.5).

*usability issues:* the insight into some of the spaces i.e. head of the school's office, technical rooms is sealed.

**Fig. 1.5** Across the building the construction, electrical and ventilation systems are left visible to show how the building functions. a) Dining area b) Entrance hall

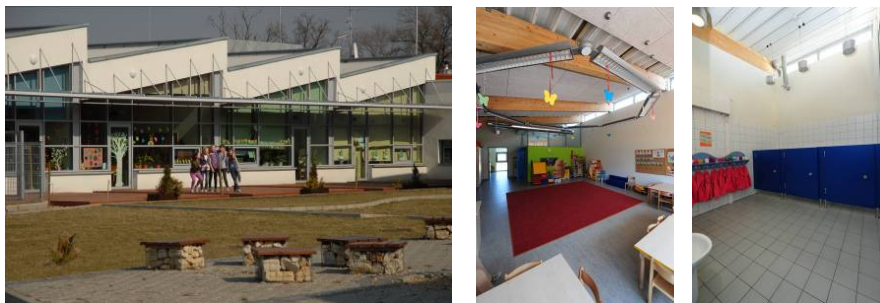
In the preschool area there is a shed roof allowing direct eastern daylight into the rooms and also into half of toilets (see Fig. 1.6). The rest of the toilets receive dispersed light through translucent upper part of partition walls. The partition walls are glazed from 2m up. Thus the need to use artificial light in the toilets is limited.

**Fig. 1.6** In the preschool area there is a shed roof allowing direct eastern daylight into the rooms and also into half of toilets. a) the shed roof from outside, b) the natural light penetrating the classrooms, c) the restroom illuminated by natural light

*how it works:* the artificial light in the day-lit toilets is sometimes on even when it is sunny – the lighting scheme needs fine tuning. The modeling of direct light penetrating the interiors, particularly classrooms and sport halls, performed at design stage were insufficient; they proved the exclusion of direct sunlight by fixed horizontal sun louvers on the 20th of June at midday only. Lower angles of solar light were not taken into account. In result in all the classrooms and sport halls glare and over heating became an instant problem. Internal blinds were installed and are in constant use. In the sports hall were the blinds have not been mounted so far the windows are temporarily sealed with paper. Another thing is that shad-
