# Comparison of design intentions and construction solutions delivered to enhance environmental performance and minimize carbon emissions of a new public school in Wrocław

Magdalena Baborska-Narozny<sup>1</sup> and Anna Bac<sup>2</sup>

**Abstract** The paper presents an analysis of the first public school complex in Wrocław, Poland to use renewable energy sources with an introductory summary of low emissions constructions in Poland. Described is the process of the building's delivery and a preliminary evaluation of selected design solutions. The building, completed in the year 2009, is planned for an in-depth POE to start this year – the first such broad evaluation project to be carried out in Poland. An in depth knowledge of the design and construction process, measurements taken already, feedback from the occupants, and tracks of all faults reported so far, allow a preliminary evaluation of the building's environmental performance. A comparison of total energy consumption and CO<sub>2</sub> emissions between the analyzed building and two other selected schools from Wrocław is included. It is based on energy bills for all fuel sources used. It indicates energy efficiency of the

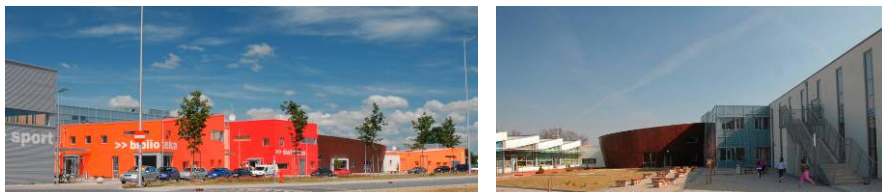
**Fig 1.1** a) View towards school entrance zone with distinct volumes housing different functions. b) View towards a courtyard between school and preschool wing. A copper volume with dining room is shared by the two functions

The 6000-square-meters building accommodates 450 pupils and 100 pre-school children. There are 80 employees in the building including: teachers, administration and technical staff. The school's population is divided between two classroom wings with shared entrance lobby, library, sport and dining facilities. The third wing with a separate entrance is dedicated to the preschool. The dining area serves as a connection point between the school and the preschool (see Fig. 1.1).

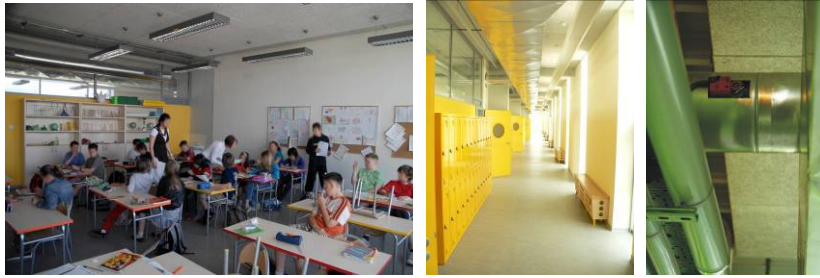
Fig 1.3 a) Classroom with MV ducts visible, b) Corridor with MV ducts visible, c) Location of the control gear for MV at ceiling high

F) Precise measurements of air flows, internal temperatures and indoor air quality are yet to be taken. The overall evaluation indicates poor usability of the system. It was meant to be controlled by the BMS, but lack of facility manager and lack of competence of the users causes frustration. Separate controls of the air

flow rates are provided for each classroom, however their location at the corridor at ceiling height and the need to use a screwdriver makes it impossible for the teachers to make adjustments in air flow rates. The need to call for technical assistance often results in asking for turning the ventilation off and opening the windows (see Fig. 1.3).
